# Manhole Inspection Summary

Manhole # S37KK\_023MH

Insp Date: **3/20/07 9:26 AM**

**Location** Address: **1900 HOMEWOOD AVE**

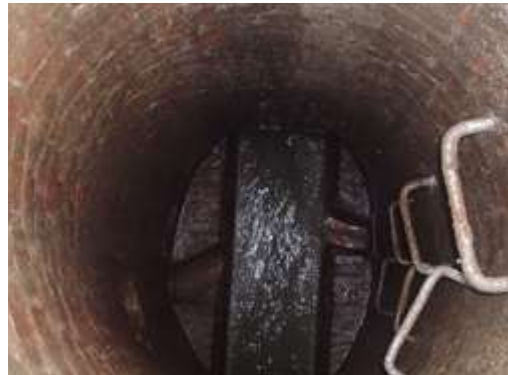
Top View

Infiltration: ☐ None ☒ **Joint** ☐ Cracks ☐ Mortar ☐ Roots ☒ **Wall**

Count: **7** Missing: **0** ☒ **Corroded**

Corbel infiltration. Corroded steps. Bench debris.

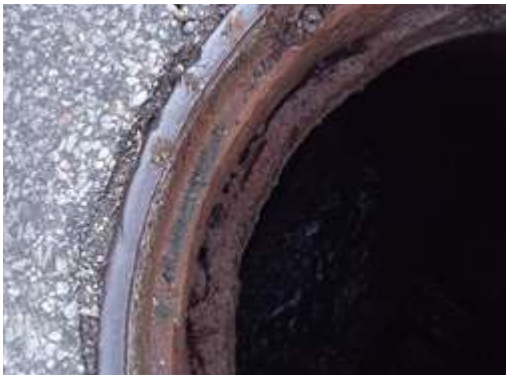
Defect

Offset: **1** (in.)

Frame offset. Frame leaks.

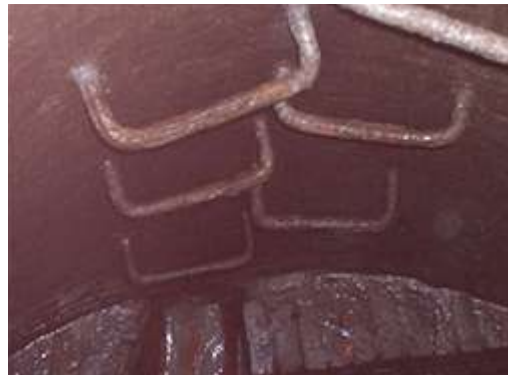
Defect

Corroded steps.

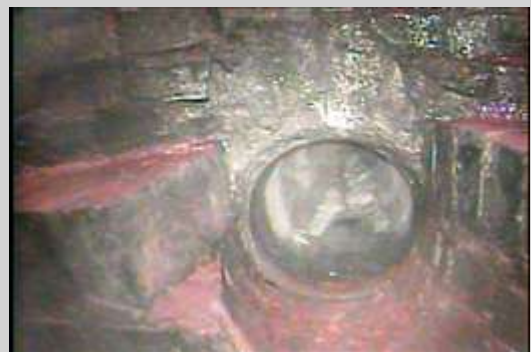
Drop In @ 9 O'Clock

Drop: **Outside** Rod and Bar  
Angled: **Yes** Reading: **11.21** (ft.)  
Inv Depth: **12.21** (ft.)  
Drop Condition: **Open**
